# Marine Atmospheric SCC of Unsensitized Stainless Steel Rock Climbing Protection

A. Sjong · L. Eiselstein

**Abstract** A failure investigation into the root cause of fixed austenitic stainless steel climbing anchor hardware in tropical marine climates has been presented. The incident 316L climbing anchor was fixed in a seaside limestone cliff in southern Thailand and underwent transgranular chloride stress corrosion cracking (TGSCC) after 10 years of service. Since stainless steel does not normally undergo stress corrosion cracking (SCC) at ambient temperatures, the conditions known to promote ambient temperature TGSCC of austenitic stainless steel are reviewed. A mechanism that may give rise to TGSCC in limestone climbing anchors in warm marine environments is postulated.

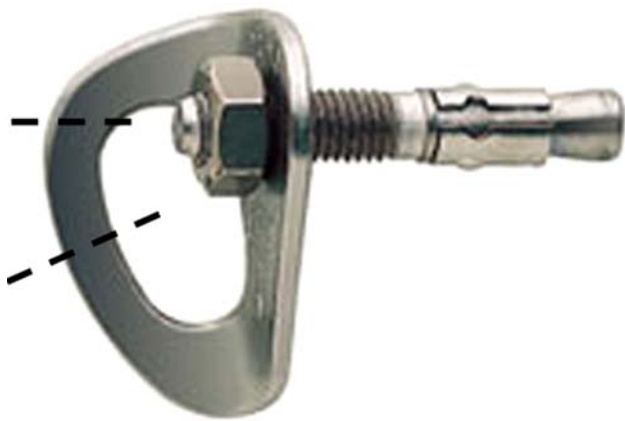
**Fig. 1** Photograph of typical rock climbing bolt used for fixed protection an austenitic stainless steel expansion bolt, nut, and 316L hanger (most common). Dashed lines indicate fragment recovered after failure and available for analysis

1. the hanger was not sensitized and had not cracked intergranularly;
2. no iron contamination was found on the hanger;
3. the hanger material was Type 316L stainless steel, and was not high sulfur stainless steel, such as Type 303; and
4. crevice corrosion cannot be responsible for the TGSCC since cracking was observed on the hanger section that extended away from the rock surface (see Fig. 1).

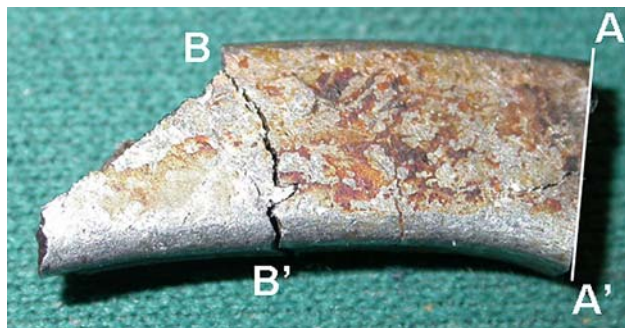
A fractured hanger fragment segment (Fig. 2) from a limestone cliff at Railay Beach (Fig. 3) in the Krabi Province of southern Thailand was available for analysis. Geologically, the limestone cliff is tower karst, part of the Ratburi group [2]. The hanger was reportedly installed in 1994, approximately 15 m above a cliff base that contacts the ocean at high tide. In 2004, the 316L hanger fractured when tested by hand and a fragment recovered for analysis. Since SCC of unsensitized austenitic stainless steels does not normally occur at ambient temperature in chloride (Cl) environments at near neutral pH such as seawater or during marine atmospheric exposures [3–29], a preliminary study was undertaken to determine the type of SCC that occurred. The purpose of this study was threefold: determine the type of SCC occurring in the 316L material; compare this SCC failure with other rare reports of ambient temperature transgranular chloride stress corrosion cracking (TGSCC) incidents, particularly with laboratory studies conducted as follow-up work to SCC failures in indoor swimming pool atmospheres [19–21, 30, 31]; and to evaluate two titanium (Ti) materials, unalloyed and Ti-6Al-4V, currently used in place of stainless steel at coastal climbing areas.

**Fig. 2** Fragment of hanger after 10 years at Railay Beach in Krabi Province, Thailand. Section A–A' shows area sectioned for metallography. Fracture B–B' shows pre-existing fracture at which the sample was broken open for SEM/EDS examination

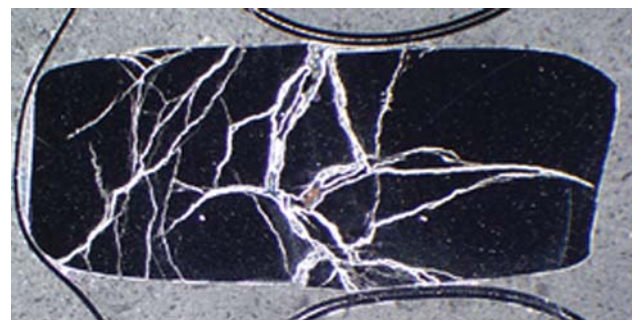
A cut along Line A–A' shown in Fig. 4 was made to expose a transverse cross section of the hanger fragment. Extensive cracking through the hanger thickness was observed

**Fig. 4** Stereomicroscope view of hanger transverse cross-section (Section A–A', shown in Fig. 2)

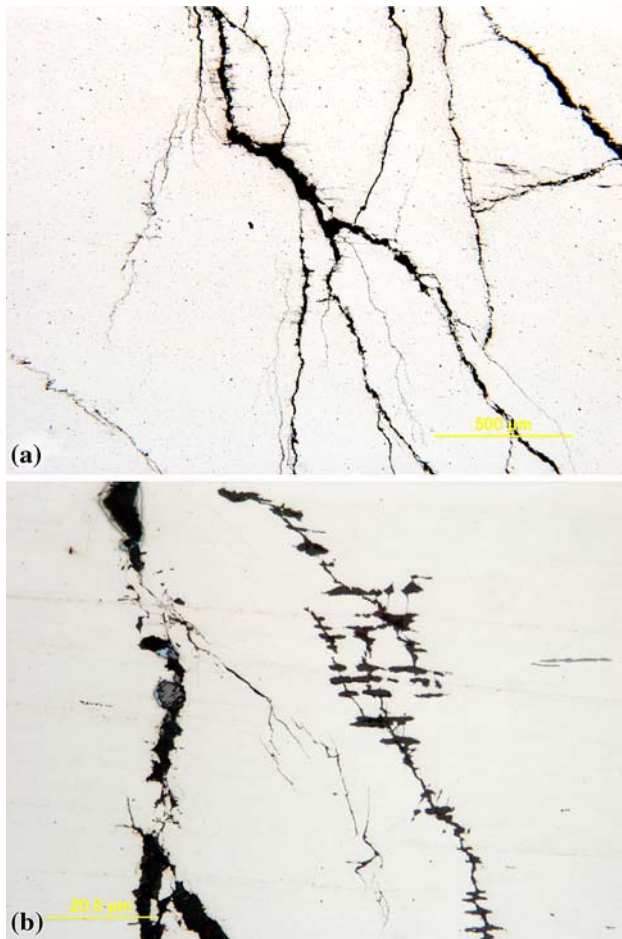
**Fig. 5** Optical micrographs of unetched microstructure (Section A–A', shown in Fig. 2)

when examined with a stereomicroscope. Optical micrographs of the unetched microstructure (Fig. 5a) show the presence of highly branched cracks. Higher magnification showed that the cracks tend to follow manganese sulfide (MnS) inclusions (Fig. 5b). An optical micrograph of the etched microstructure clearly shows that the failure was a result of TGSCC (Fig. 6).

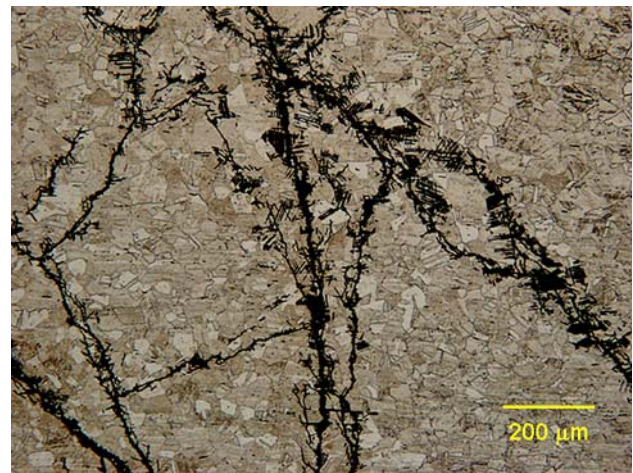
**Fig. 6** Optical micrograph of etched microstructure (Section A–A', shown in Fig. 2)

result of Cl-induced TGSCC. The evidence for this sub-critical crack growth mode was the presence of multiple and branching cracks, a generally transgranular crack path, the presence of Cl within these cracks (Figs. 5–9), the lack of general or localized corrosion, the absence of necking associated with ductile rupture, and the absence of beach marks or striations associated with fatigue.

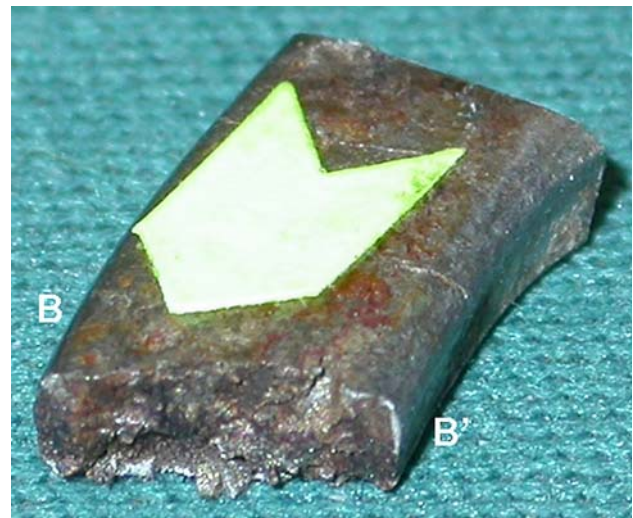
The fragment was broken open along the large, pre-existing crack (labeled B–B') as shown in Fig. 2. A photograph (Fig. 7) and a SEM micrograph (Fig. 8) of the fresh fracture surface are provided. EDS of the corrosion product on the freshly exposed surface (Fig. 8) shows extremely high levels of magnesium (Mg) compared to the 316L alloy elements of iron (Fe) and chromium (Cr). Smaller amounts of chlorine (Cl), sulfur (S), potassium (K), and calcium (Ca) were also observed. XPS/ESCA results (Table 1) of the deposits on the freshly exposed fracture surface, after sputtering to a depth of between 50 and 100 Å, also showed high levels of Mg as well as Cl, sodium (Na), and Ca. A substantial amount of nitrogen (N) was found as well. This may indicate the presence of

**Fig. 7** Photograph of fresh fracture surface generated by breaking open along pre-existing cracks in hanger (Fracture B–B', shown in Fig. 2)

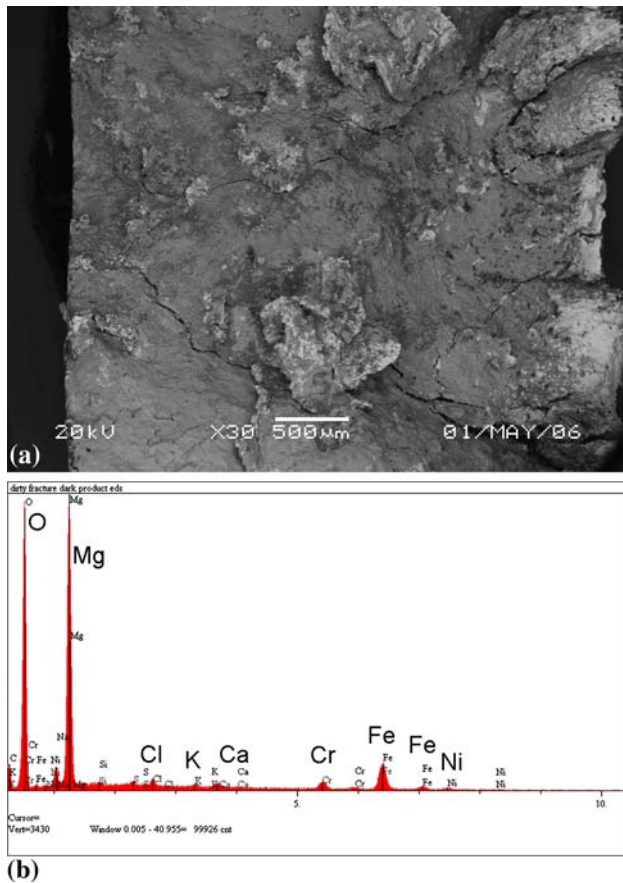
ammonium, nitrites, or nitrates. The Mg level of the near-surface corrosion product, as detected by XPS/ESCA, was ten times higher than the Ca levels, six times higher than the Na levels, and five times higher than the Cl levels. These cation/anion ratios are distinctly different from seawater, where Na levels are typically eight times higher than Mg, Mg five times higher than Ca, and Cl 15 times higher than Mg [33, 34].

**Fig. 8** (a) SEM micrograph of fresh fracture surface prior to cleaning, Fracture B–B'. (b) EDS spectrum of fresh fracture surface prior to cleaning, Fracture B–B', showing high levels of magnesium (Mg): O, oxygen; Cl, chloride; K, potassium; Ca, calcium; Cr, chromium; Fe, iron; and Ni, nickel

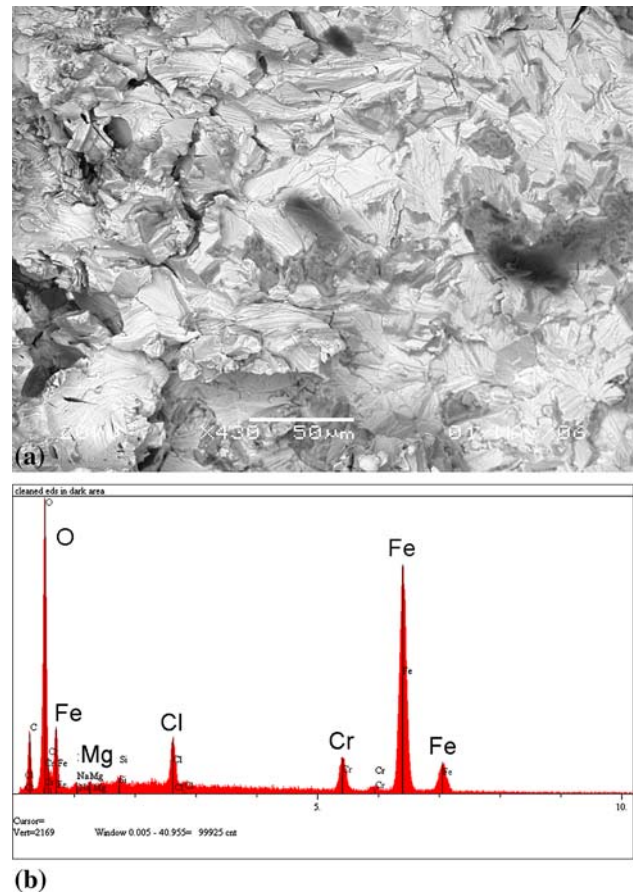
The fracture surface was then cleaned by sonication in isopropanol. An SEM image of the cleaned fracture surface shows transgranular fracture (Fig. 9). Cl was still detected on the fracture surface after cleaning. Since there was insufficient material available for chemical or hardness tests, an exemplar stainless steel hanger of the same brand

**Fig. 9** (a) SEM micrograph of SCC fracture surface after cleaning showing transgranular fracture, Fracture B–B'. (b) EDS spectrum of SCC fracture surface after cleaning showing transgranular fracture, Fracture B–B', showing high levels of chloride (Cl): O, oxygen; Mg, magnesium; Cr, chromium; and Fe, iron
