# Marine Atmospheric SCC of Unsensitized Stainless Steel Rock Climbing Protection

A. Sjong · L. Eiselstein

**Abstract** A failure investigation into the root cause of fixed austenitic stainless steel climbing anchor hardware in tropical marine climates has been presented. The incident 316L climbing anchor was fixed in a seaside limestone cliff in southern Thailand and underwent transgranular chloride stress corrosion cracking (TGSCC) after 10 years of service. Since stainless steel does not normally undergo stress corrosion cracking (SCC) at ambient temperatures, the conditions known to promote ambient temperature TGSCC of austenitic stainless steel are reviewed. A mechanism that may give rise to TGSCC in limestone climbing anchors in warm marine environments is postulated.

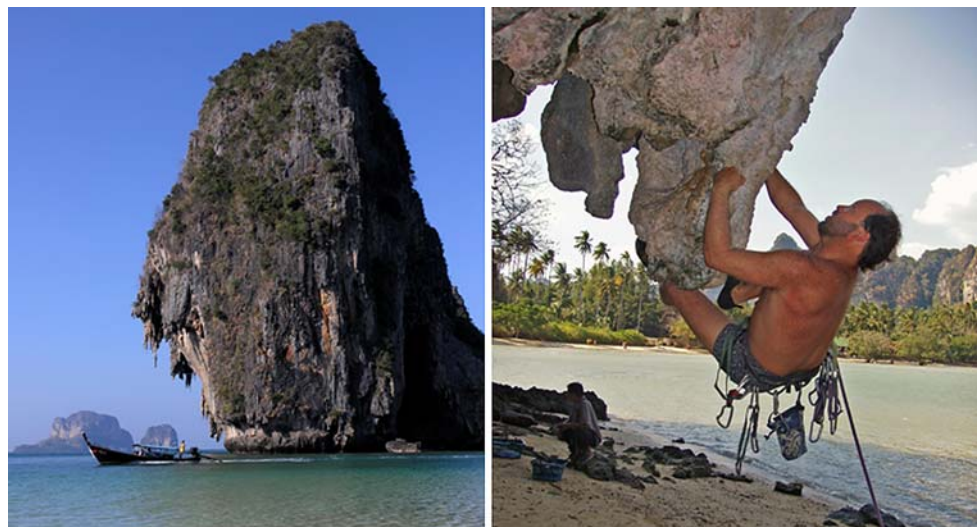
**Fig. 3** Photographs of limestone formations (tower karst) near Phranang and Railay Beach in the Krabi Province, Thailand, a popular rock climbing area. Photographs reprinted with permission from Karl Bralich at peaklightimages.com

Tower karst, such as the limestone formations found at Railay Beach, are 30–300 m in height with vertical or overhanging sides. The base of the tower often contains numerous stalactites and caves, characteristics particularly attractive to climbers (Fig. 3). While karst is found all over the world, tower karst is only found in warm, tropical climates where the lush vegetation favors their formation. The abundant vegetation and microorganisms found in tropical climates create soil waters that contain a high level of dissolved CO<sub>2</sub> [2]. This low pH acidic soil water is much more effective in dissolving limestone than rainwater. The acidic water dissolves the base of the tower at a much higher rate than the sides (Fig. 3), resulting in tower formation. The hot tropical sun that evaporates water and reprecipitates minerals results in features such as stalactites (Fig. 3).

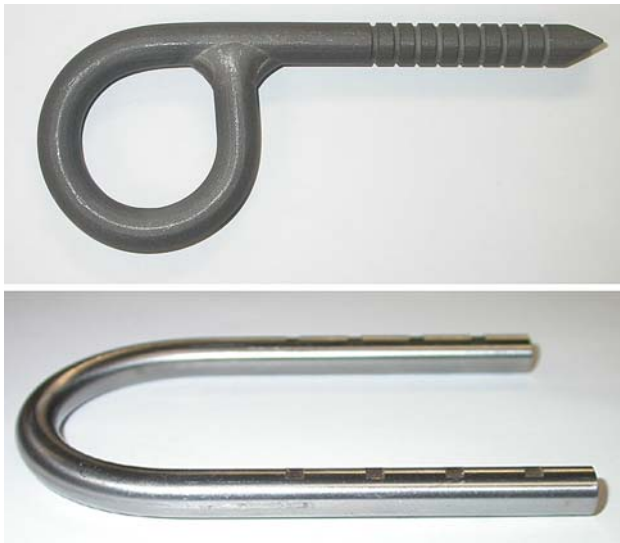
**Fig. 10** Photographs of glue-in titanium bolts used for fixed climbing protection; unalloyed welded titanium (top) and Ti–6Al–4V U-bolt (bottom)

Ti–6Al–4V chemistry (Table 4). Hardness of the titanium bolts was 180 and 336 Hv, respectively (Table 2).
